# **NGL RECOVERY PLANT: TREATER OPTIMIZATION FOR WATER AND MERCAPTAN REMOVAL**

Nancy Hillenbrand and Keith Clark  
UOP LLC  
Houston, Texas

A number of process and product considerations contribute to the reliable operation of a molecular sieve natural gas treater. When the natural gas feed dehydrator to an NGL Recovery Plant was upgraded to a treater for removal of water and mercaptan sulfur, the plant soon reported a performance shortfall on the retrofitted treater. A series of escalating on-site troubleshooting and product evaluation efforts were performed that contributed to the plant's ability to completely turn around its treater performance.

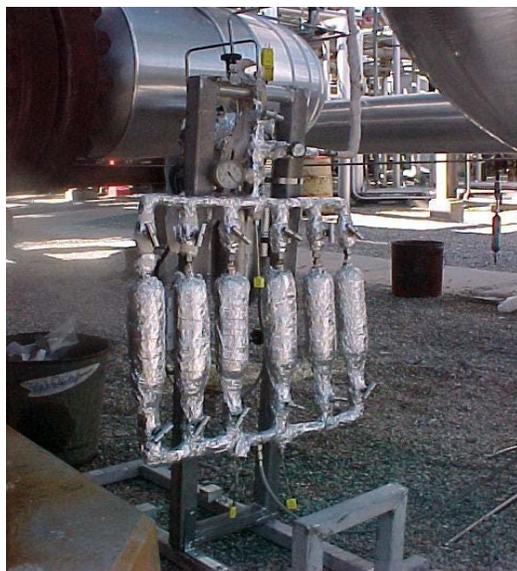
Figure 4 - Product Aging Test Rig

Two small test units (Figures 4 and 5) with local flow, pressure, and temperature indicators were brought to the site along with a portable gas chromatograph used to speciate the sulfur of the influent and effluent of the adsorbent test products. The test protocol again called for accelerated aging of the test adsorbents (Figure 4). These aged products were then (Figure 5) installed on a slipstream of the commercial treater feed for side-by-side comparisons. This test skid included a small molecular sieve pre-dryer so that the dynamic sulfur adsorption capacity of the products could be measured without interference from water. The mercaptan species in the treater feed included, on average: 35 ppmv methyl mercaptan, 70 ppmv ethyl mercaptan, 50 ppmv iso-propyl mercaptan, and 25 ppmv sec-butyl mercaptan.
